**BELMONT MANSION, A CONDITIONS SURVEY  
OF THE ORNAMENTAL PLASTER CEILINGS OF  
ROOMS 101 AND 205**

**Amy Cole Ives**

**A THESIS**

**Historic Preservation**

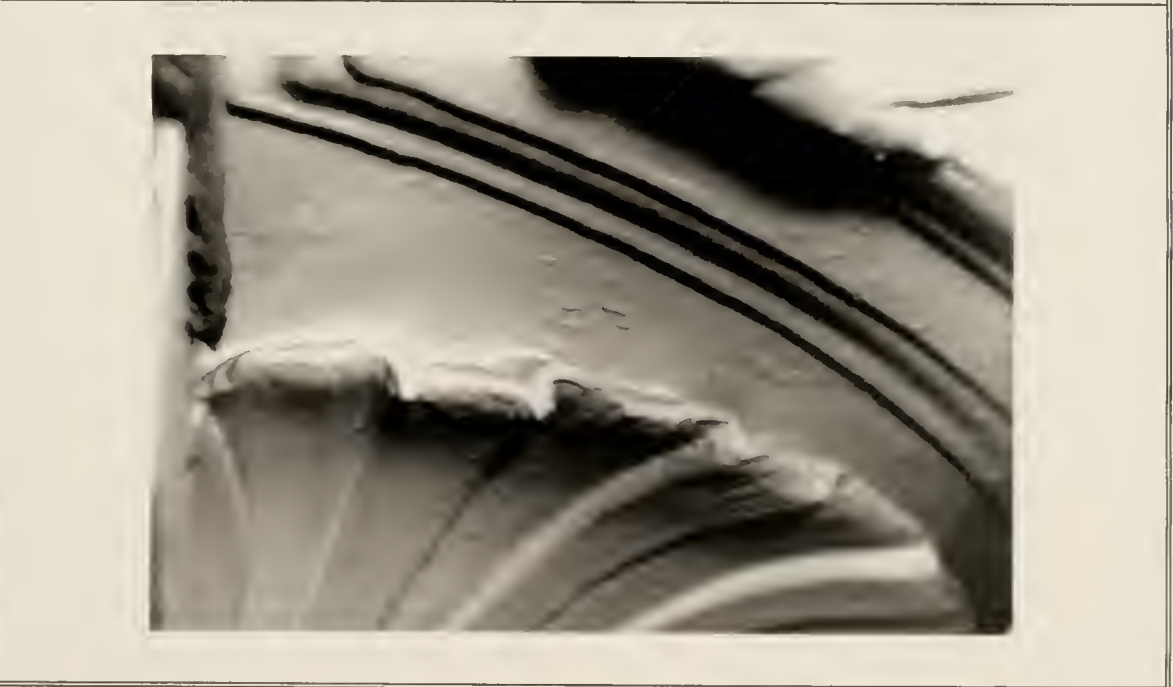
**Figure 14 Detail of southeast corner shell.**

the back side, it seems more likely that they would have been modelled by hand on a slab and then attached to the ceiling, rather than modelled in place (Figure 14).

Considering the size, projection and detail of the shells, they were probably modelled by hand on a slab and then attached to the ceiling.

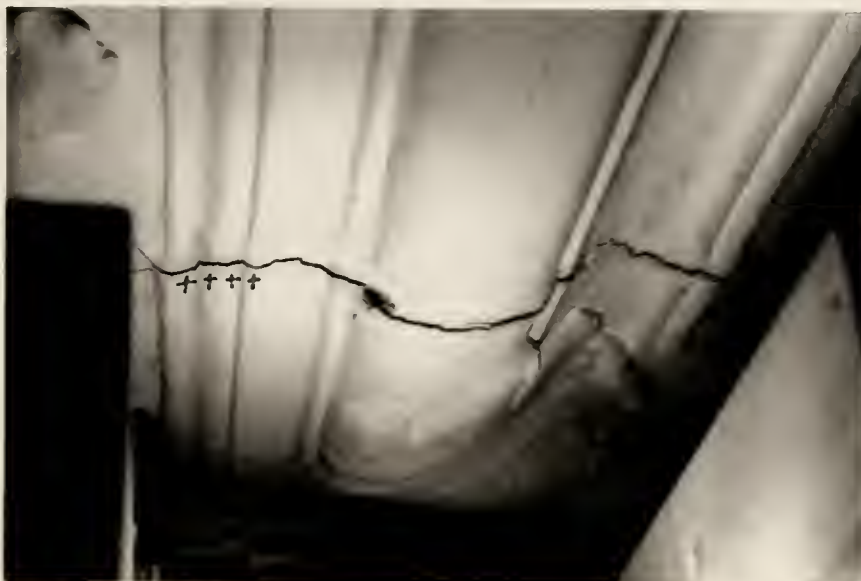
**Vertical Displacement**

Settlement of one side of a crack relative to the other side - resulting in planar discontinuities.

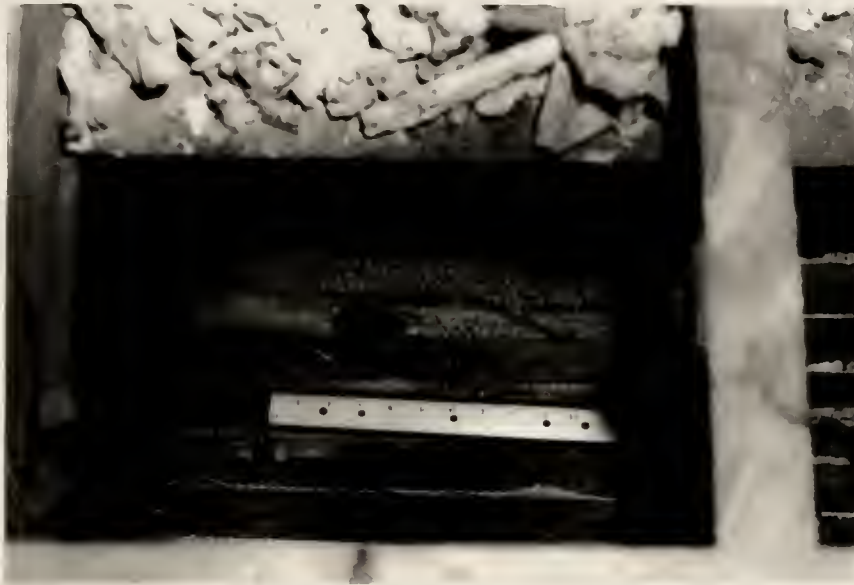
### Patching

Subsequent infill, replacement keys and surface repairs made to the original plaster.

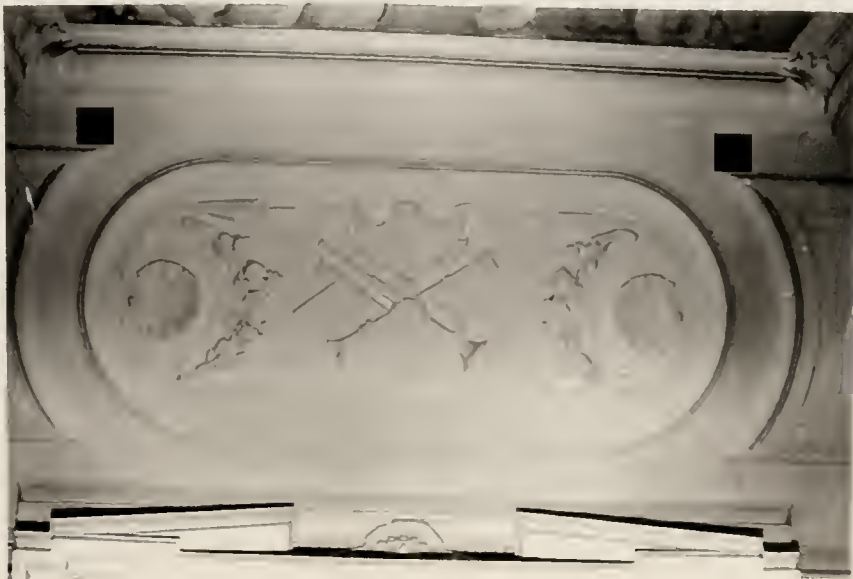
### Plaster Loss

Absence of one or both layers of rough and finish coats of plaster.

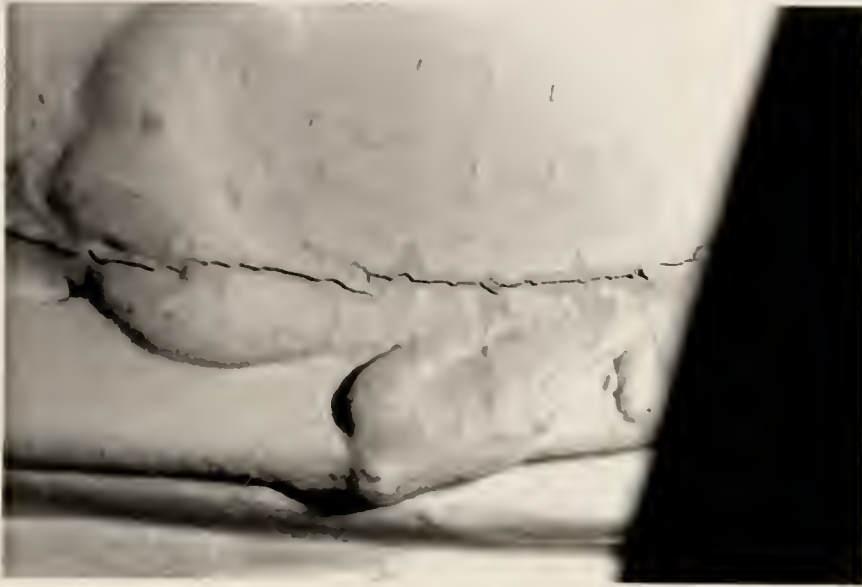
### Staining

Discoloration from water damage or by deposition of minute deposits of matter within the pores of the painted plaster.

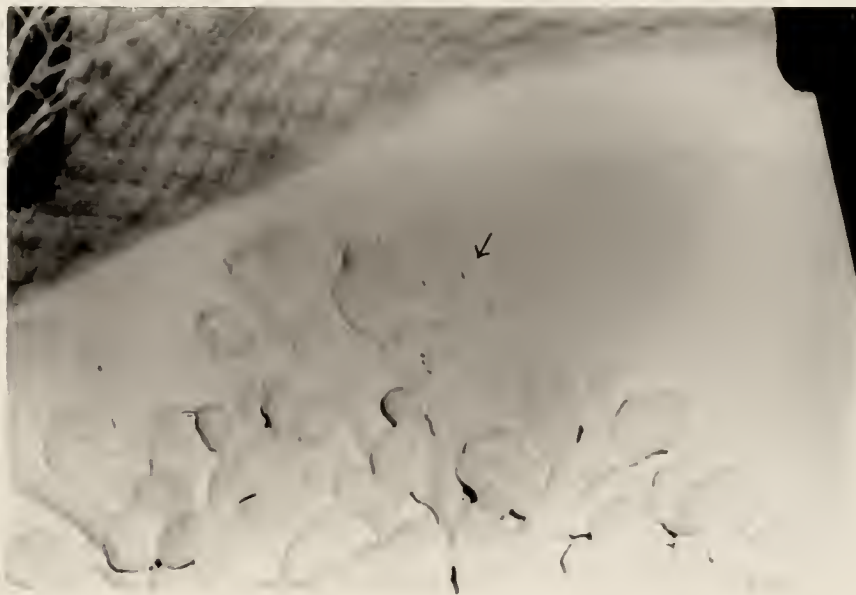
Large scale map cracking observed on painted ceiling relief elements of room 205.

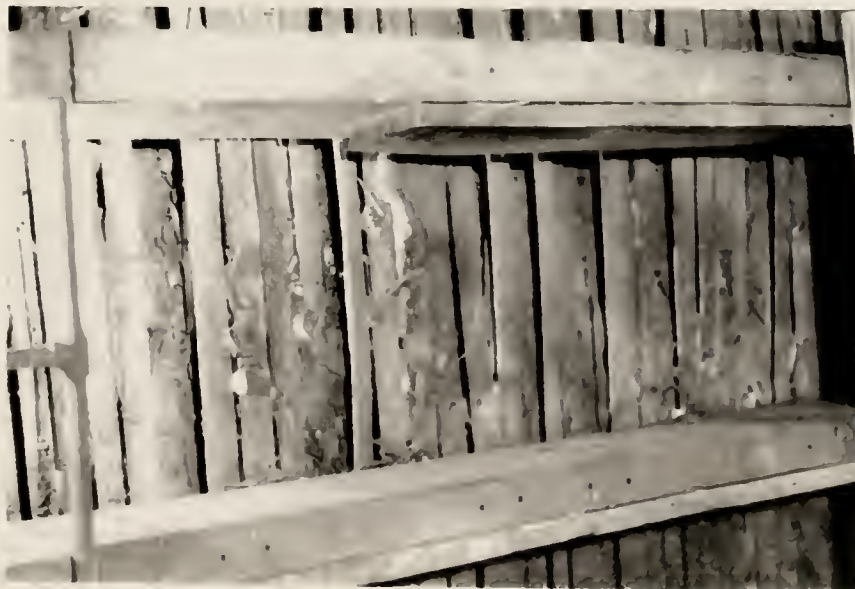
### Detachment

Separation between the lath and plaster or plaster and floor joists. (Note: no detachment observed between plaster layers).

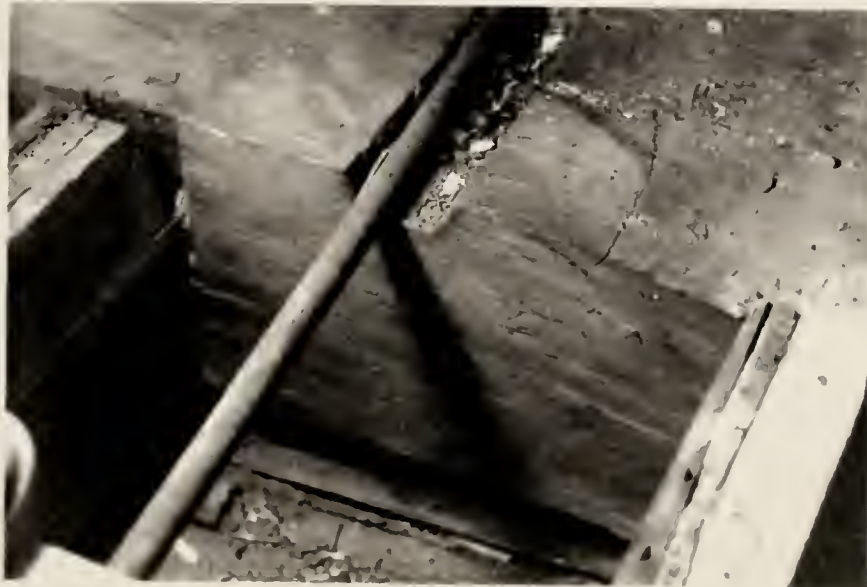
**Withdrawn Tenon**

Joist tenon that is pulling out of its mortise in the supporting summer beam.

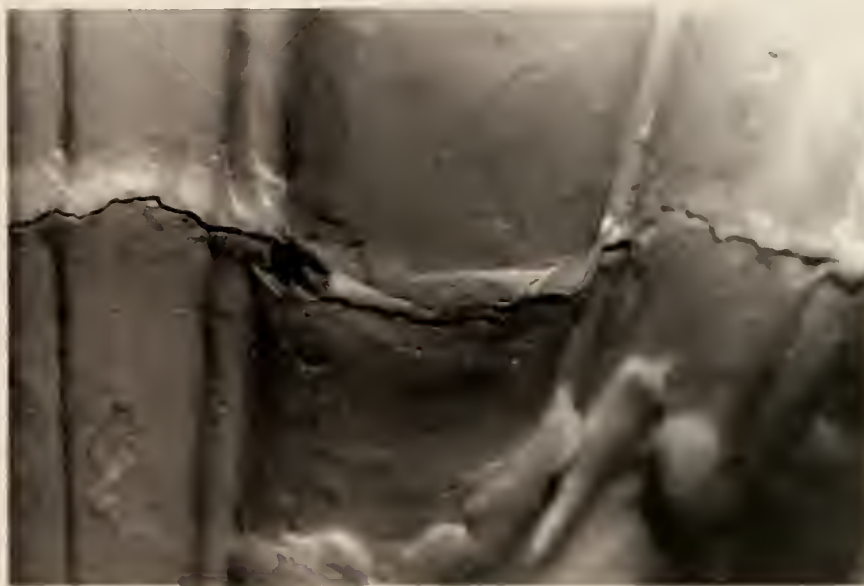
**Figure 34** Detail of patched crack on south side of east cartouche.

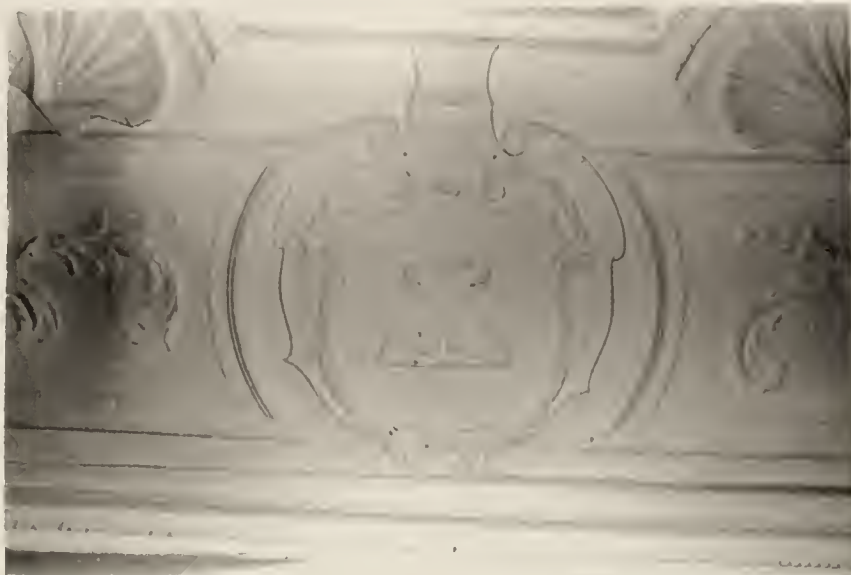
In short, with the exception of the large crack on the south side of the west cartouche, many of the cracks recorded in the survey can be seen in nearly the same condition in the photographs from the early 1990s as they are today. There are of course limitations to any conditions assessment done from photographs that have no scale included in the image, but comparatively, the progressive deterioration visible in the photographs from 1990, 1992 and today, of the crack on the west cartouche is substantially greater than in any other recorded cracks (Figures 35, 36). A second source of photographs of the plasterwork is Philip Wallace's *Colonial Houses of Philadelphia* from 1931.<sup>71</sup> In one of his photographs, the crack on the south side of the east cartouche can be seen, though significantly smaller than it is today. A second photograph shows the west cartouche without a crack on its south side, but with a noticeable bulge or crack extending east through the empty central field. This section of plaster, which runs along the large deflected summer beam, was replaced in 1986 with new plaster and expanded metal lath as part of the "facelift" Belmont received for the Junior League's designer showcase.<sup>72</sup> At this point, further discussion and diagnosis of the condition of the plasterwork cannot be made without first considering the condition of its framing, lath and plaster key support.

**Figure 36 Detail of crack on south side of west cartouche in 1996.**

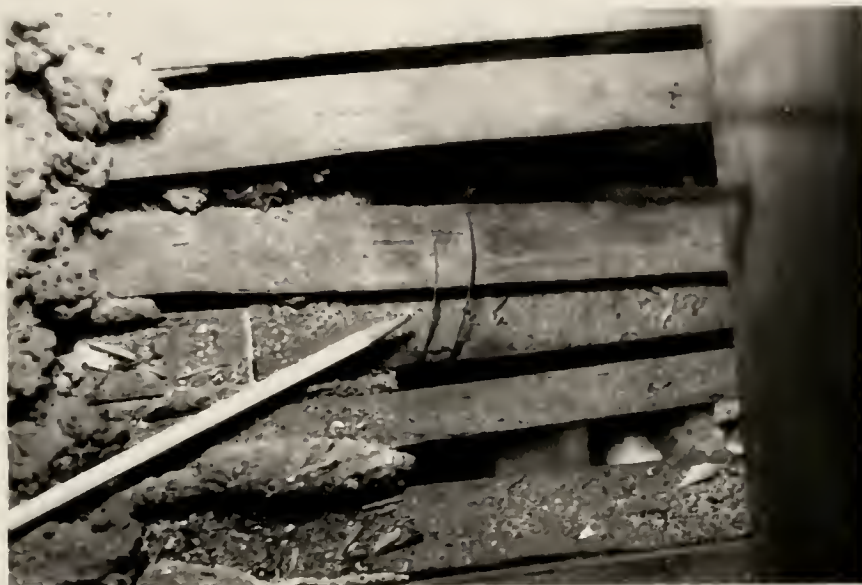
**Figure 37** Detail of wire looped over lath in room 204.

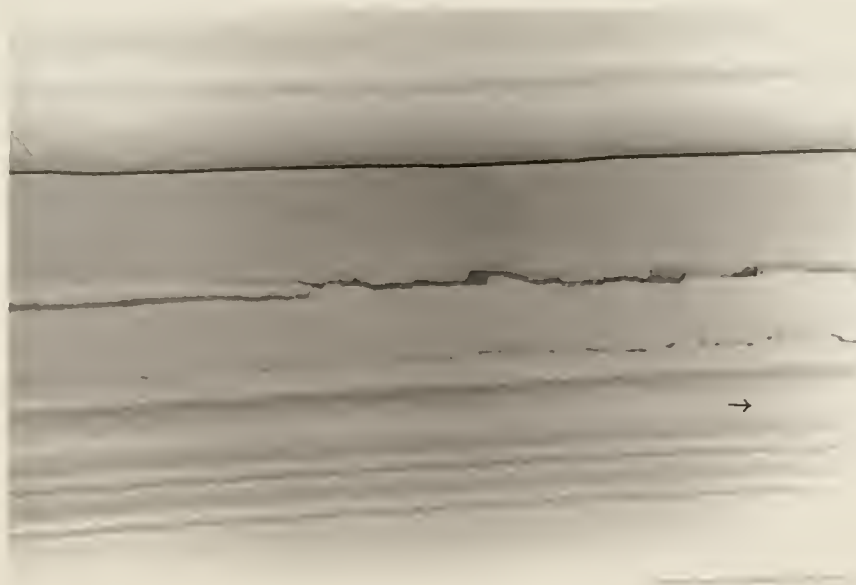
**Figure 38** Detail of cut in room 101 west cornice.  
From Martin Jay Rosenblum, R.A. and Associates, 1992.

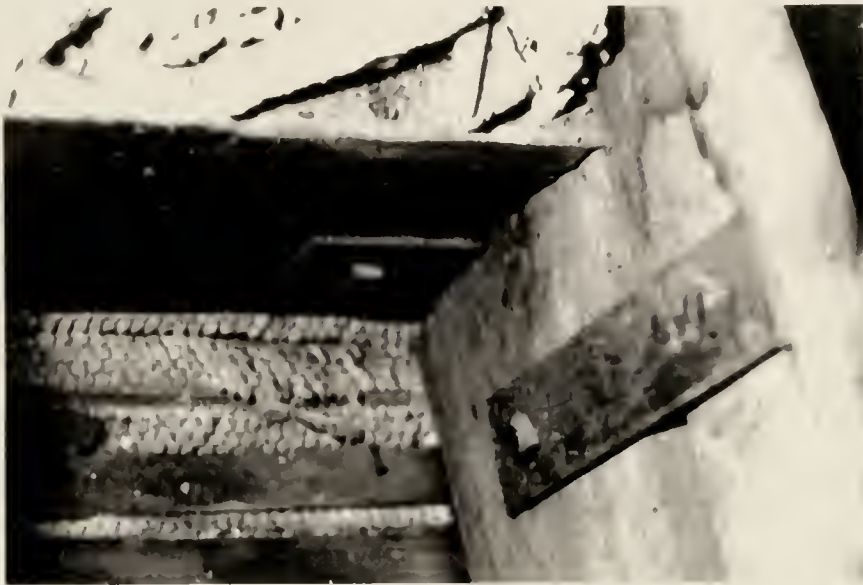
**Figure 39** Detail of Metal strap tenon support and floorboard leveler with metal strap.

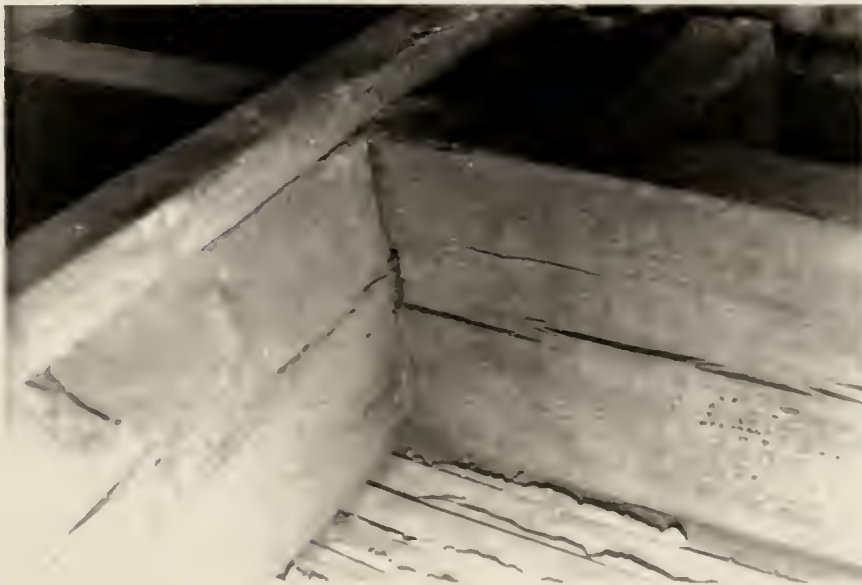
**Figure 40** Detail of Joist 8.

J8 is cracked and tenoned into a cracked section of the fireplace header in room 201.

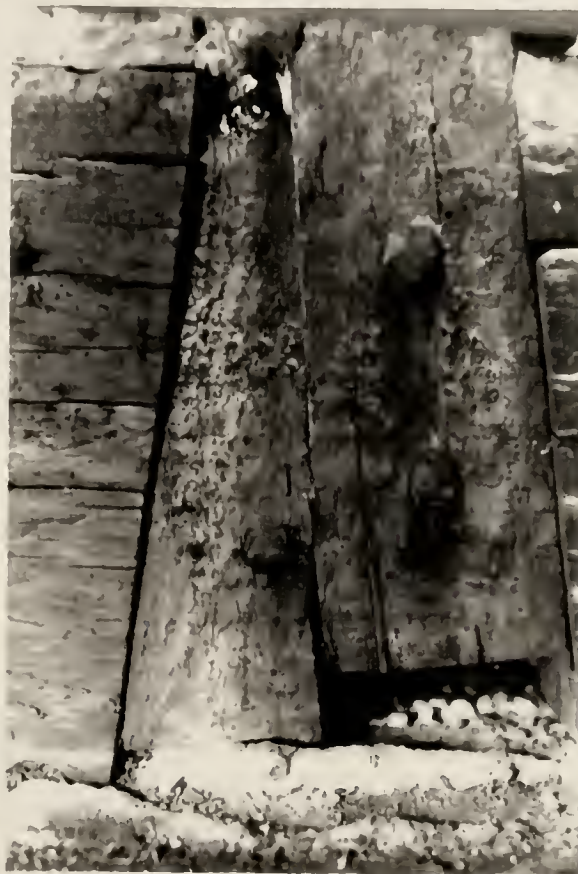
Figure 41 Detail of split dove-tail joint of king post truss.

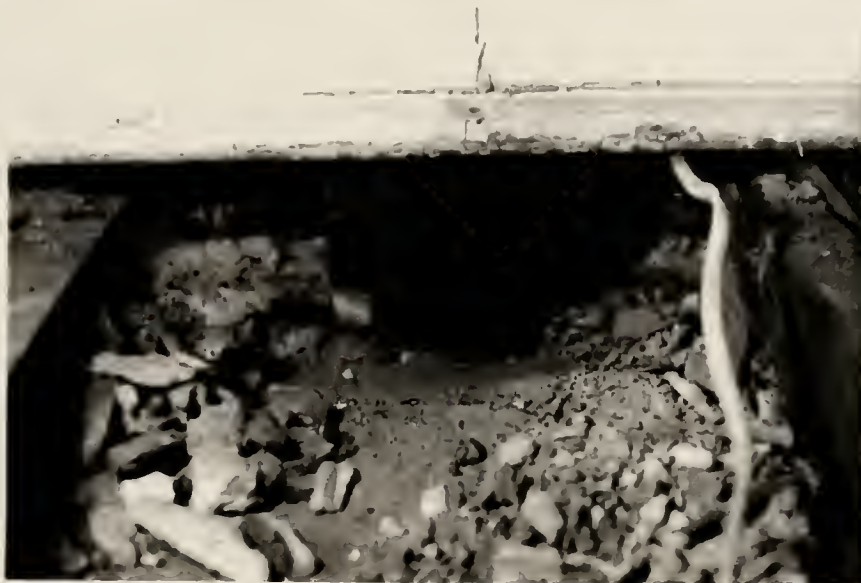
**Figure 42** Detail of king post partially pulled out of summer beam.

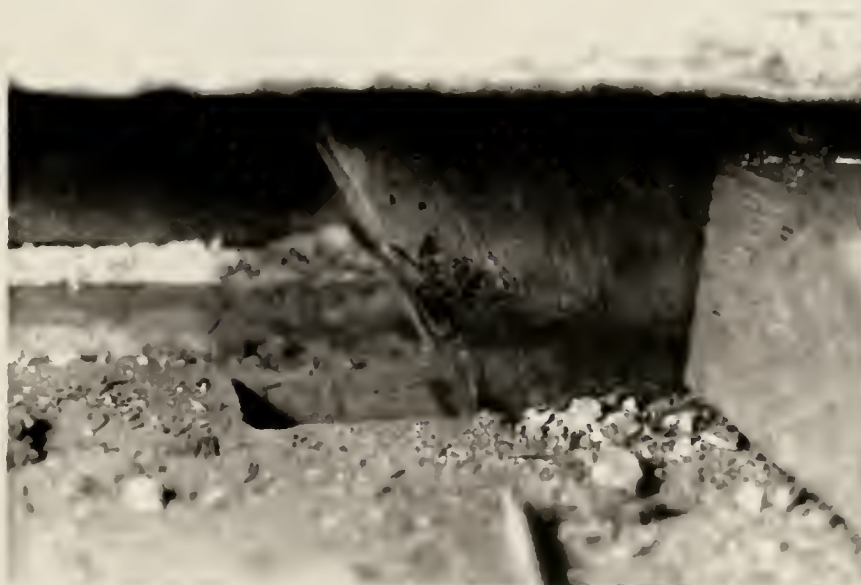
**Figure 43** Detail of western diagonal of truss partially pulled out of summer beam.

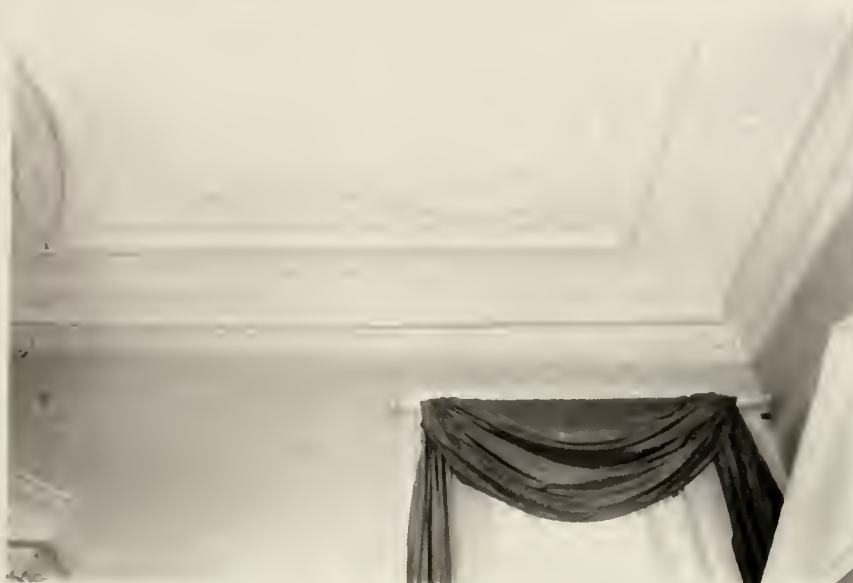
**Figure 44 Room 101 west wall cornice separation from ceiling in 1992.**  
From Martin Jay Rosenblum, R.A. and Associates.

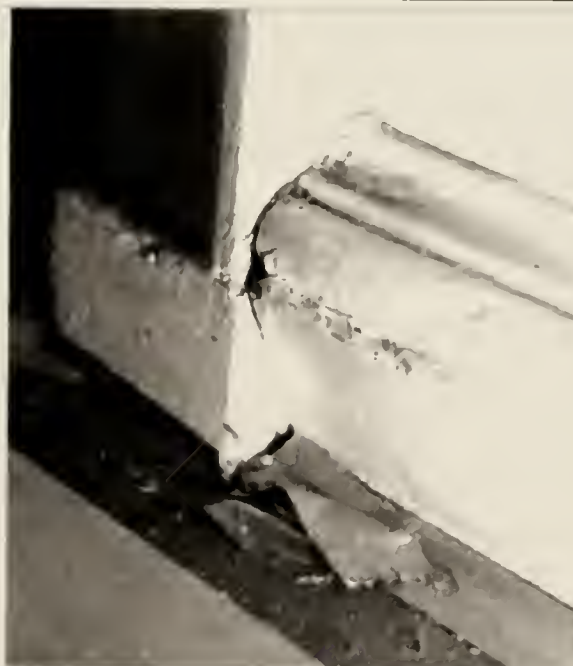
**Figure 45 Detail of room 101 south wall buckled baseboard.**
